AL-VI-B-243
Clise Farm
Miller
Private

Circa 1900

INVENTORY FORM FOR STATE HISTORIC SITES SURVEY

Clise Farm

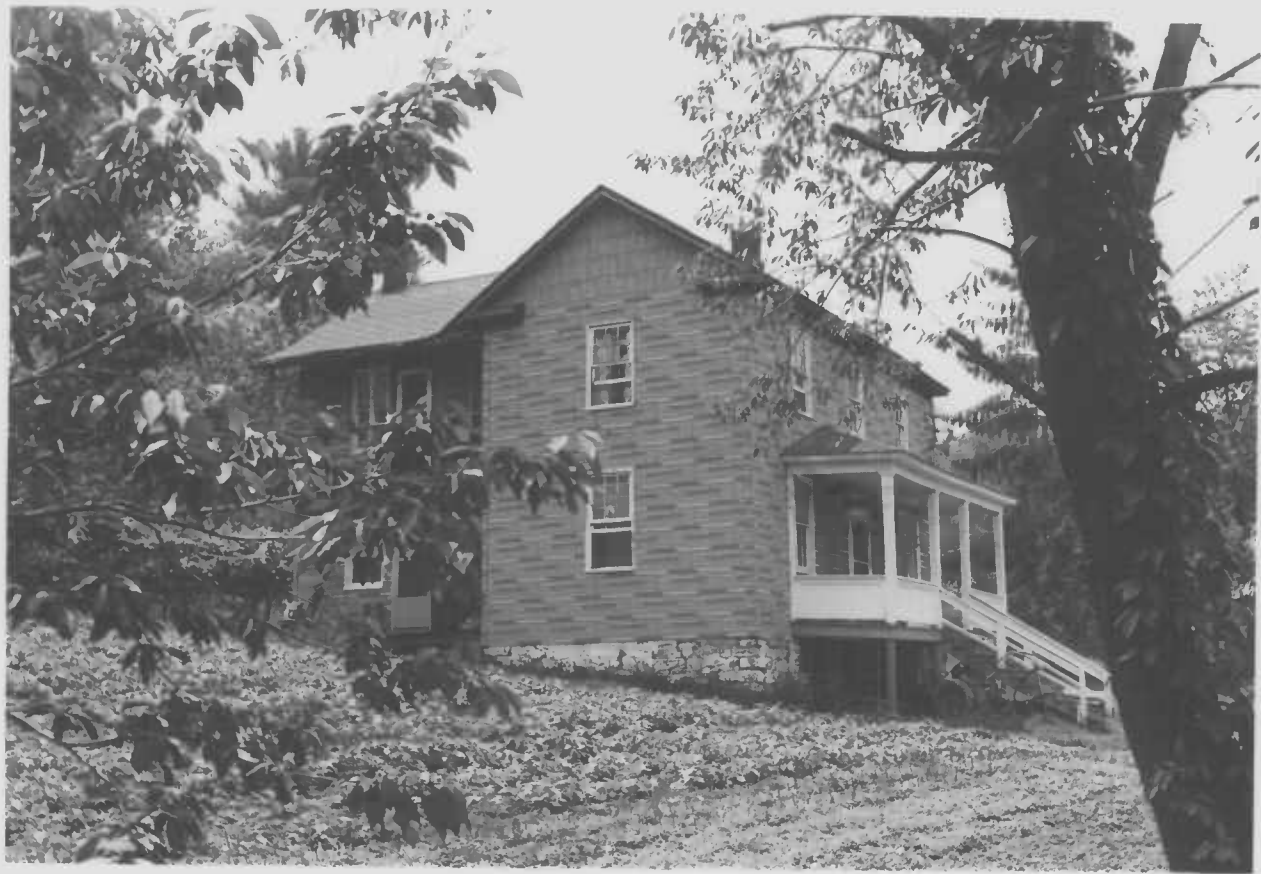
AL-VI-B-243
Clise Farm
Allegany Co., MD
David A. Dorsey 7/81
Farmhs. NW elevation

The Clise Farm is located south of Route 55 at Miller. The farm consists of a farmhouse and ten outbuildings. The farmhouse is two stories tall, three bays wide on the facade (NW elevation), and one bay deep. The house is "T" shaped due to the addition of a two story frame wing to the southeastern elevation which is two bays wide and one bay deep. The frame farmhouse has walls of tongue and groove flush boards covered with asbestos shingle siding. It rests on a high rubble stone foundation. The gabled roofs of both the main block and the addition are covered with asphalt shingles.

A porch on the facade has a hipped roof supported by capped square wooden posts. A two tiered porch on the northeastern elevation of the addition has a shed roof supported by square wooden posts. Windows are pegged 6/6 sash. An entrance in the center of the facade has a one light transom and an original door. The door has two horizontal panels and two square panels surmounted by one pane of frosted glass with an urn design. Engraved hardware of the door is original. A central chimney on the main block and an end chimney on the addition are of brick.

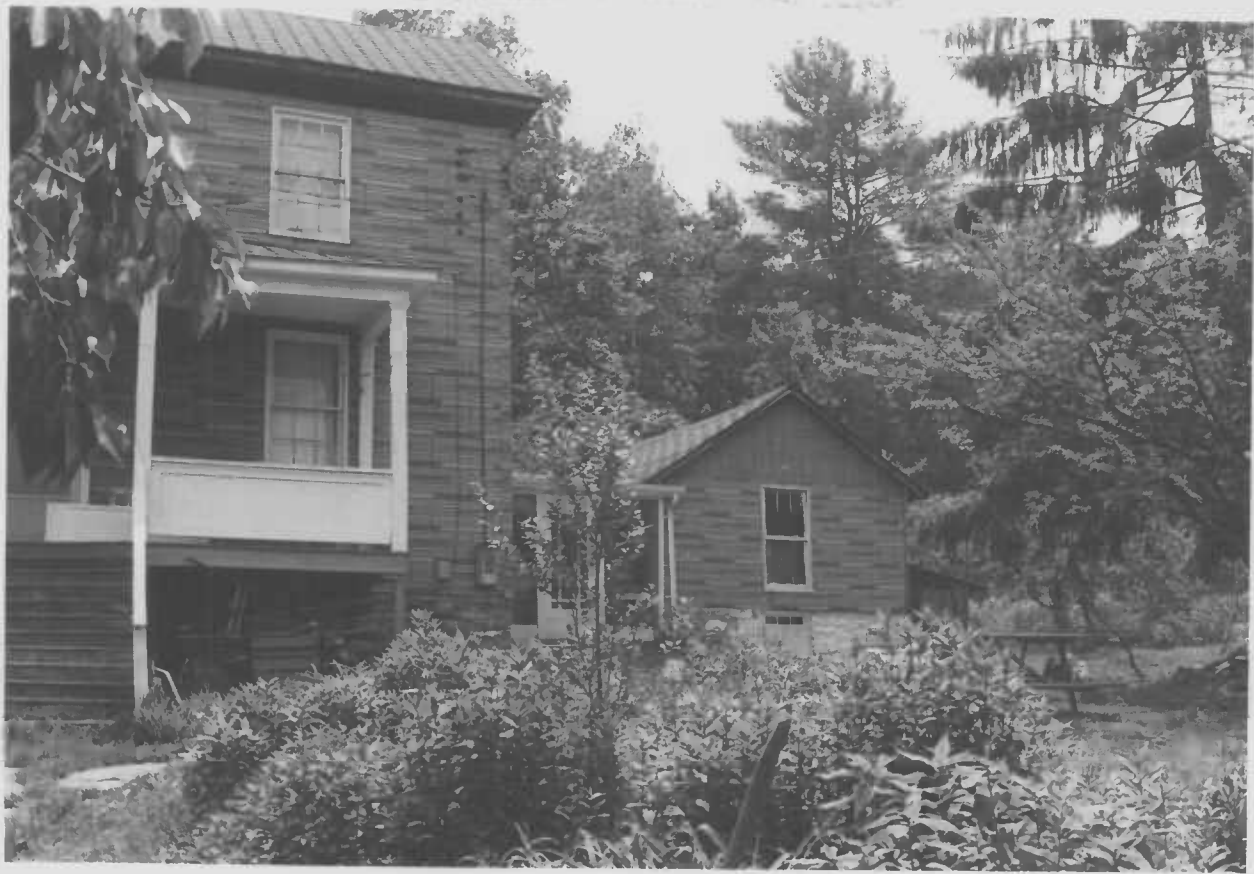
Springs. NW elev.

A springhouse is located immediately to the southwest of the farmhouse. The two buildings are connected by a small frame addition with a gabled roof. The frame springhouse is one story tall and is covered with german siding and insul brick siding. It rests on a high random ashlar stone foundation and has a gabled roof. A spring which emerges from beneath a stone retaining wall to the southeast of the springhouse flows through the foundation of the structure.

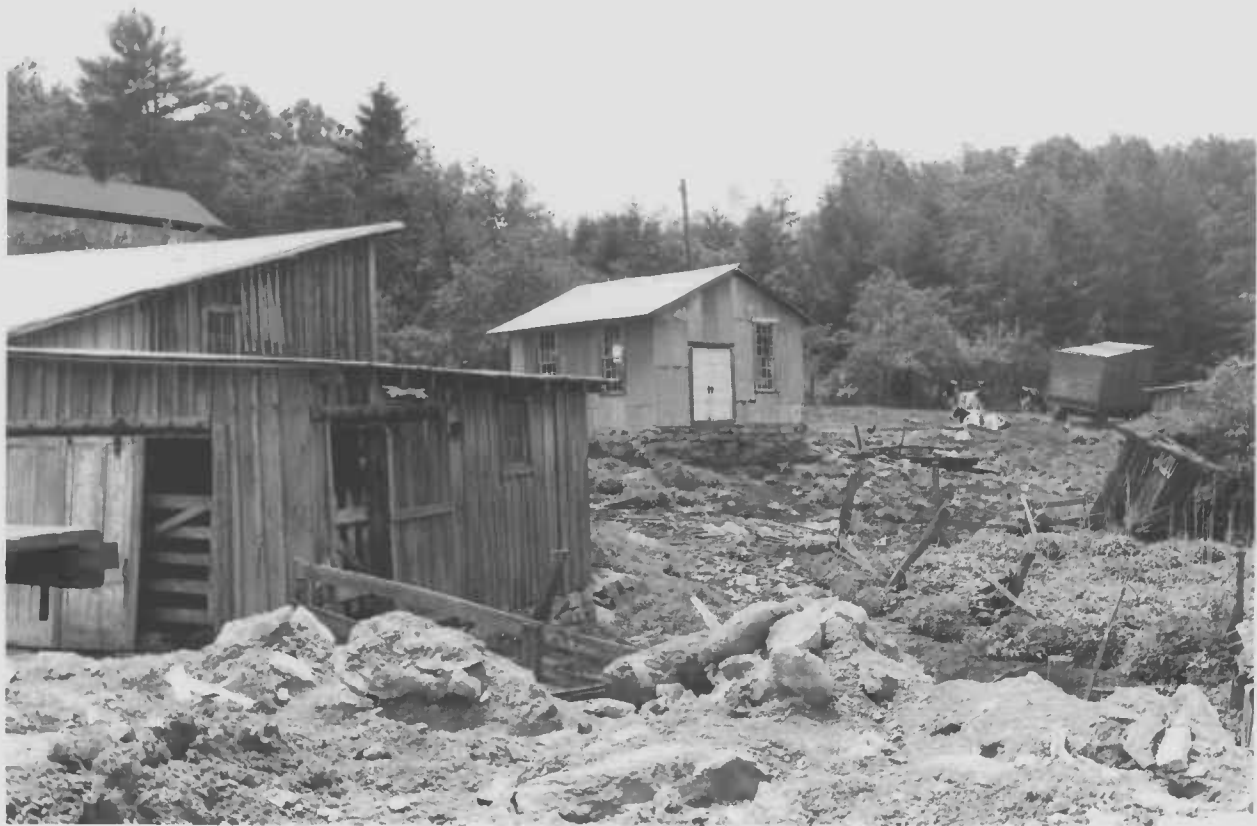
Outbldgs. View to the SW

A small frame milking house, a pavillion-like sawmill, and a recently rebuilt shop which rests on a highstone foundation are located to the northwest of the farmhouse. Two frame granaries, a drive-in, double bin corn crib, two shed roofed board and batten cow sheds, a rebuilt barn, and the foundation of a silo are located to the north of the farmhouse.

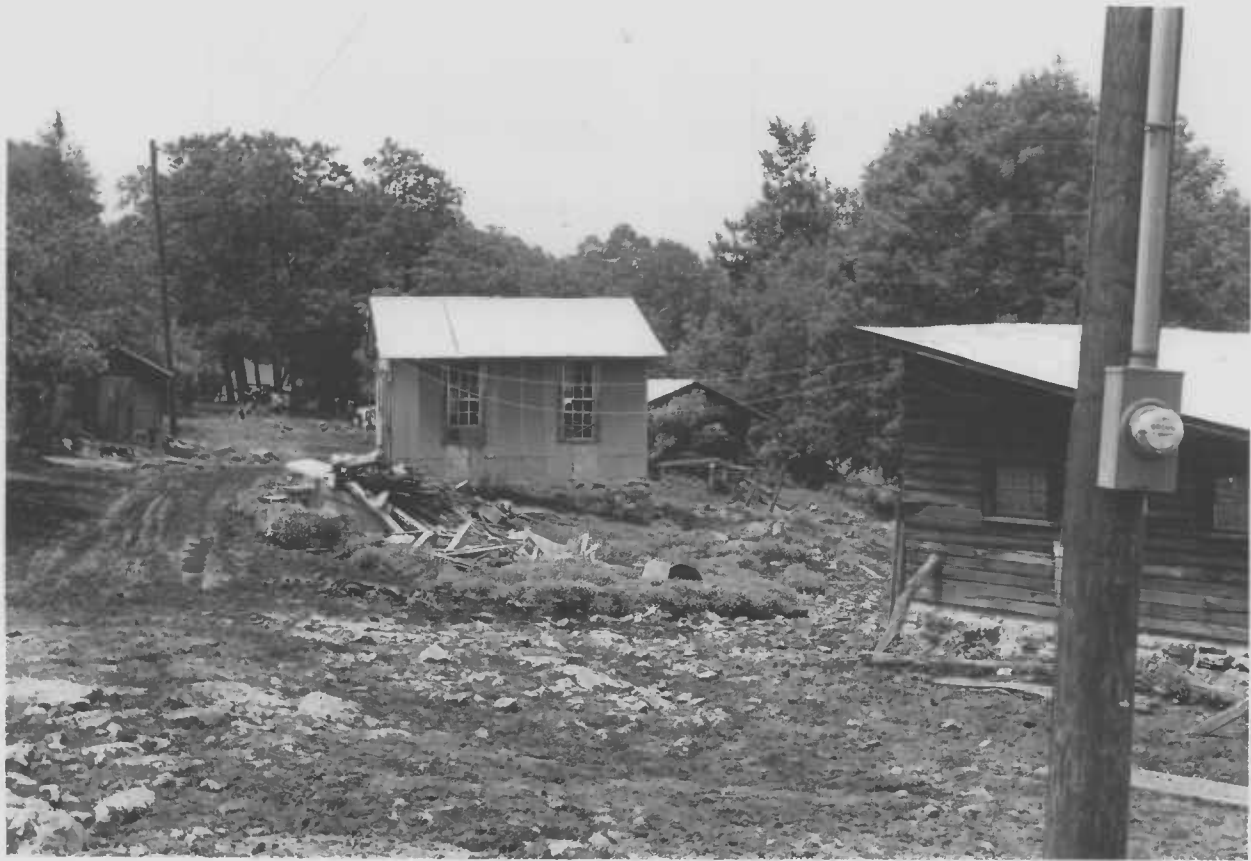
Outbldgs, View to the S

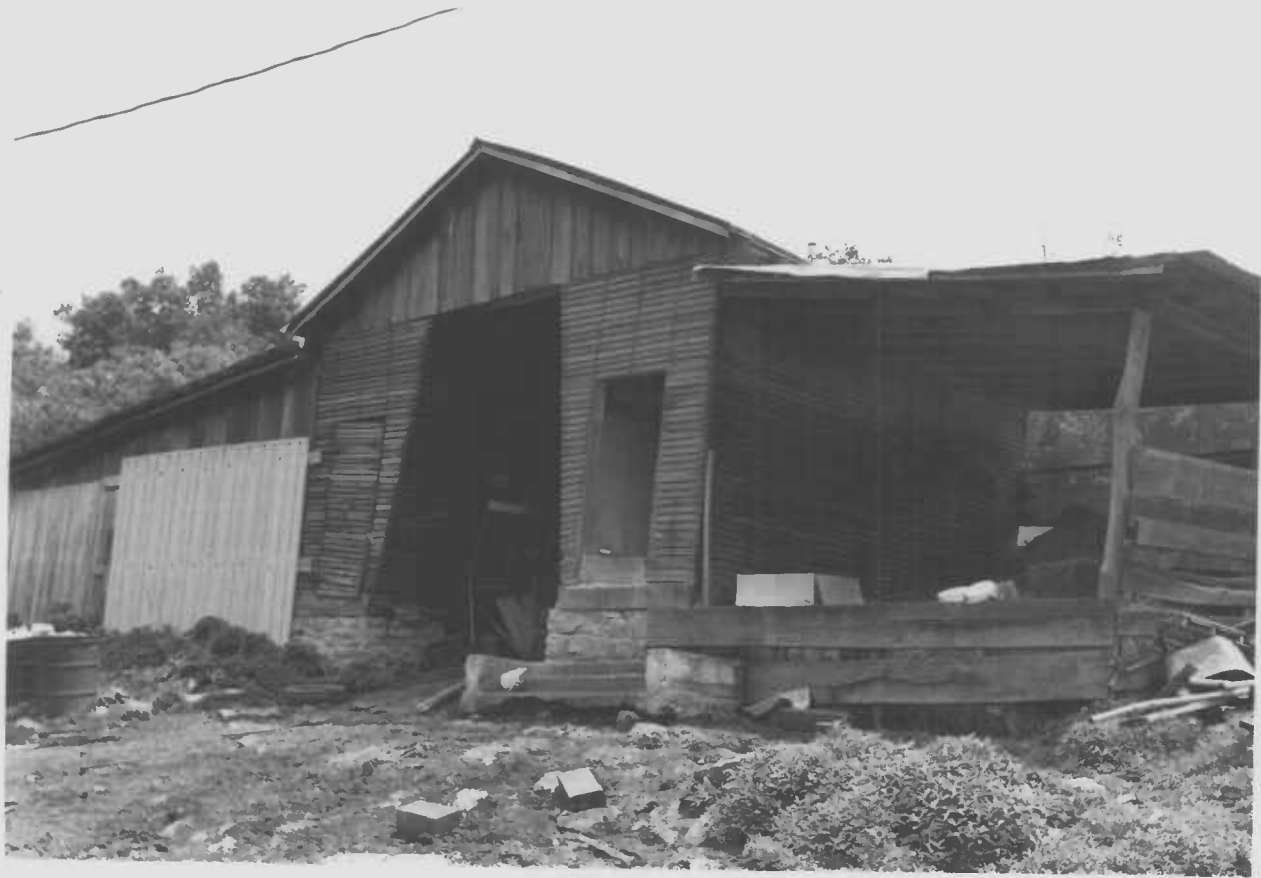
Corncrib, NW elev.
